## **Description of the "Zero" (No Project) Alternative for Roșia Montană**

WISUTEC  
Wismut Umwelttechnik GmbH  
Jagdschänkenstr. 33  
D-09117 Chemnitz  
Germany

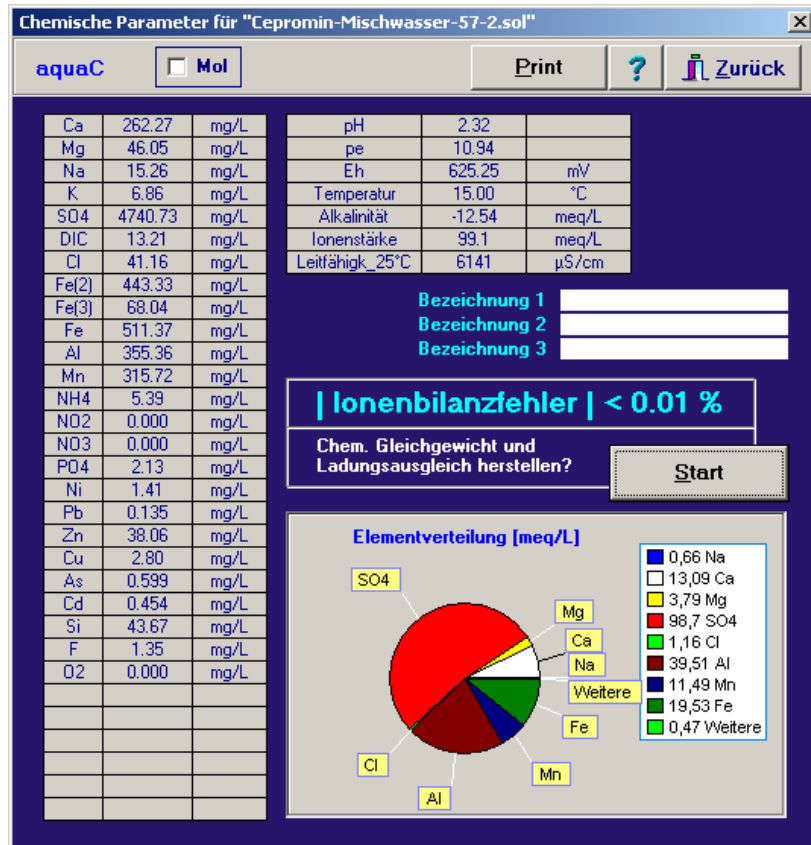
**Table 4-9. Predicted mine water quality, resulting from 50 m<sup>3</sup>/h mine water and 2 m<sup>3</sup>/h waste rock seepage, drained into the underground mine**

The composition of the mine effluent which is collected at the 714 Adit is calculated as a mixture of the water qualities in **Error! Reference source not found.** and **Error! Reference**

source not found.. The resulting, thermodynamically equilibrated<sup>6</sup>, composition is shown in Error! Reference source not found..

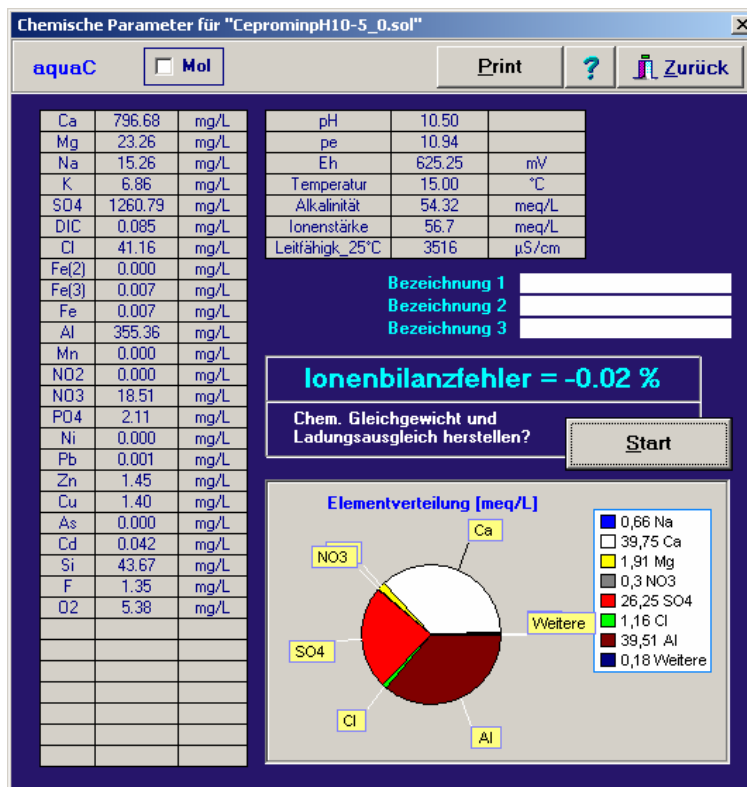
Table 4-11. Detailed composition of the outflow of treatment stage 1

The solids of the first treatment stage (mainly gypsum sludge) are removed by sedimentation.

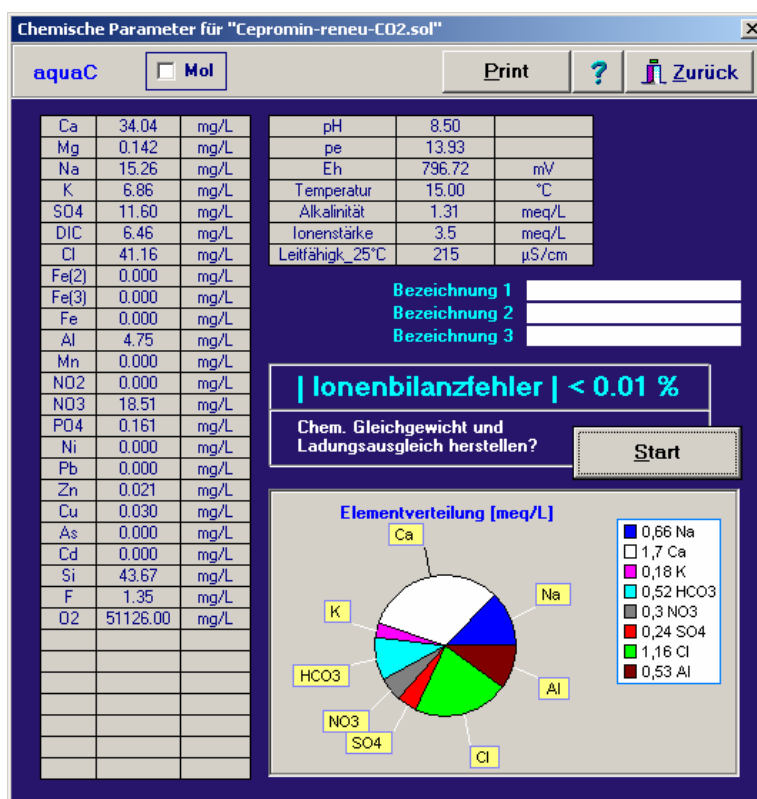
**Table 4-14. Detailed composition of the treated mine effluent**

**Error! Reference source not found.** shows the composition of the treated water which complies with the discharge limits of NTPA 001/2005.
